Midsun 570

PRODUCT DATA

MIDSUN 570 HIGH VOLTAGE INSULATOR COATING WARRANTY

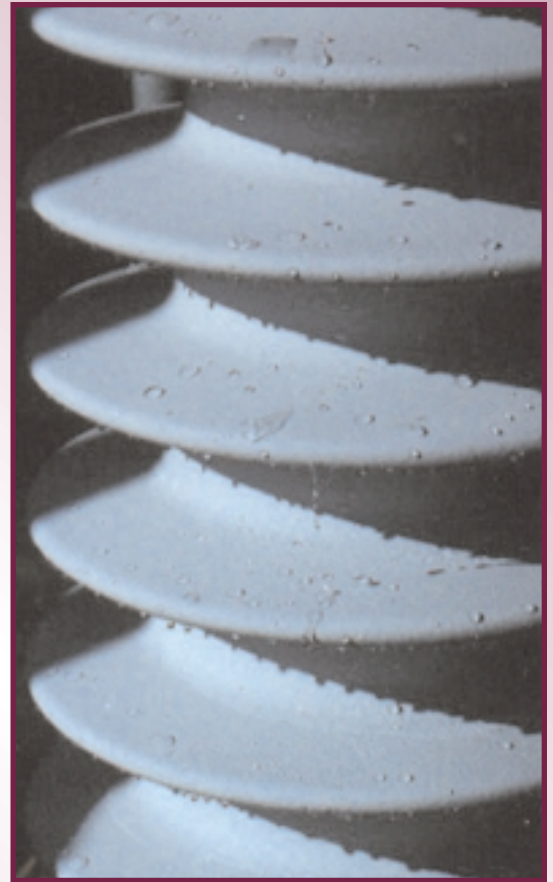
Midsun HVIC™ coating is available for *live line application*.

The non-flammable carrier solvent permits safe application under live conditions. This of course requires the use of tools designed specifically for live application.

Midsun 570 HVIC™ coating is available for **live line application**. The non-flammable carrier solvent permits safe application under live conditions. This of course requires the use of tools designed specifically for live application.

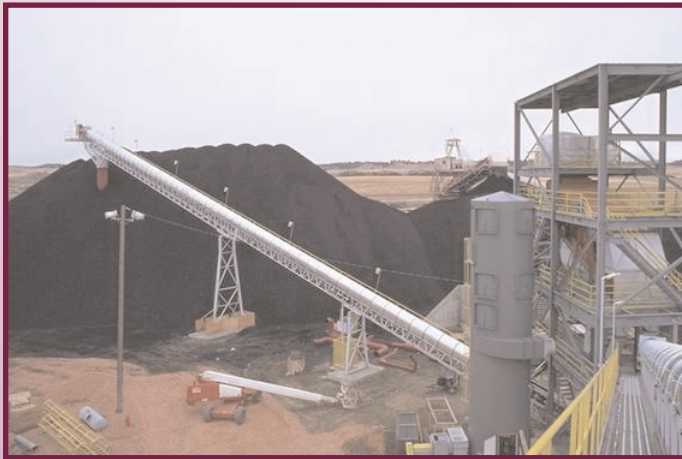
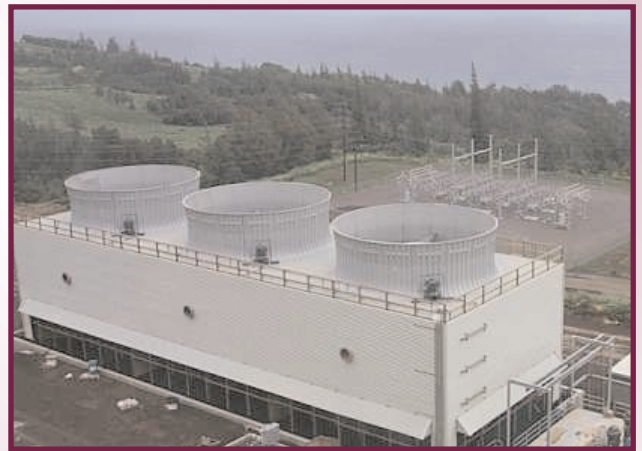
Flashover Contaminates

- Salt
- Coal Dust
- Cement Dust
- Sugar Cane Carbon
- Fly Ash
- Bird Droppings/Streamer
- Cooling Towers
- Dirt
