Midsun 570

PRODUCT DATA

MIDSUN 570 HIGH VOLTAGE INSULATOR COATING WARRANTY

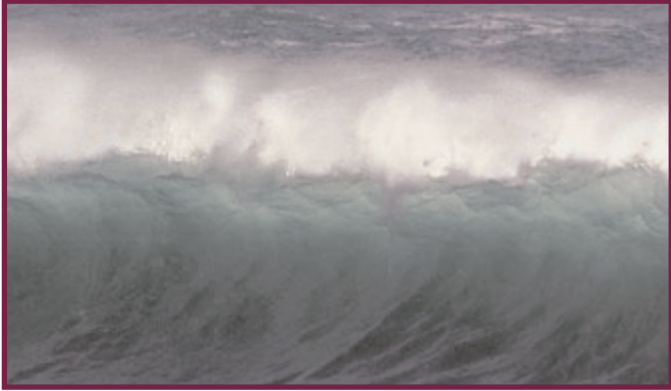
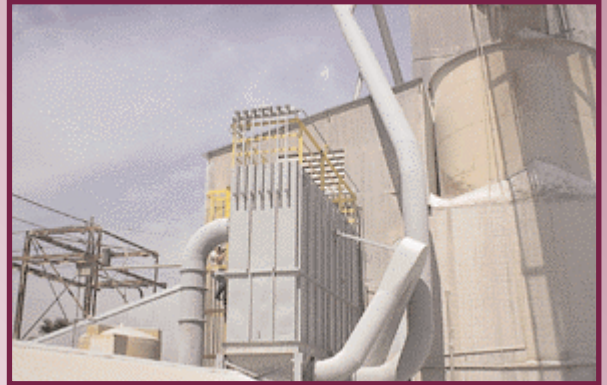
Flashover Contaminates

- Salt
- Coal Dust
- Cement Dust
- Sugar Cane Carbon
- Fly Ash
- Bird Droppings/Streamer
- Cooling Towers
- Dirt
